Test Report

Project NO. : 21MD09-013

Product : Handlebar+Stem

Test Reference : EN15194:2017 (E)

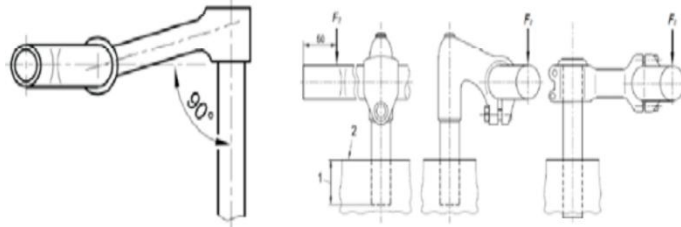
H/B+ Stem assembly-lateral bending test

For stems which have a quill for insertion into a fork-stem, clamp the quill securely in a fixture to the minimum insertion depth, or for stem extensions which clamp directly on to an extended fork-stem attach the extension to a fork-stem according to the manufacturer's instructions and clamp this fork-stem securely in a fixture to the appropriate height. Apply a force of 800N (accurate to within $0/\pm 5\%$) at a distance of 50 mm from the free end of the handlebar. Maintain this force for 1 min.

- a) Combined stem and quill
- b) Stem extension
- 1 Minimum insertion depth
- 2 Clamping block
- 3 Solid steel bar

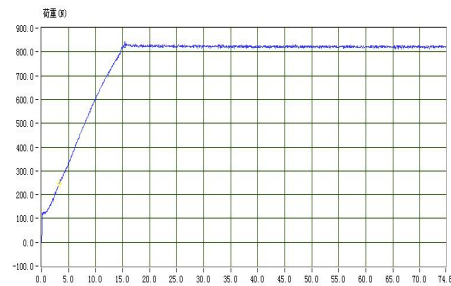
5. Appendix: Static test picture

3. Static test: acting-force:800N. Acting force place:50mm away from handle bar end lasting time:1 min

4. Pass : permanent deformation < 15mm, test based on said no crack or fracture incurred for stem

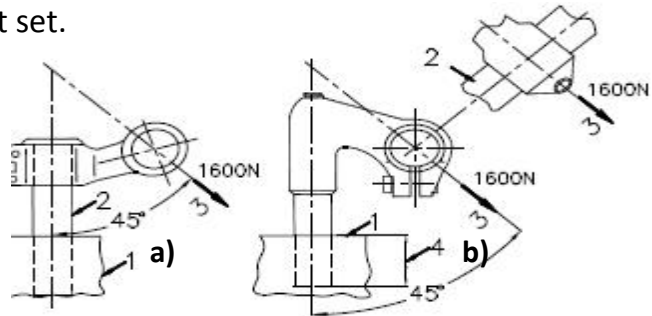
H/B+ Stem forward bending test

Stage 1 : Apply a force of 1600N through the handlebar attachment point in a downward direction and at 45° to the axis of the quill or steel bar, and maintain this force for 1 min. Release the test force and measure any permanent set.

- a) Stem extension
- b) Combined stem and quill
- 1 Clamping fixture
- 2 Solid steel bar
- 3 Applied force
- 4 Minimum insertion depth

Stage 2 : With the handlebar-stem mounted as in stage 1, apply a progressively increasing force in the same position and direction as above figure until either the force reaches a maximum of 2600N or until the handlebar-stem deflects 50 mm measure at the point of the test force and in the direction of test force. If the stem does not yield or continue to yield, maintain the force for 1 min.

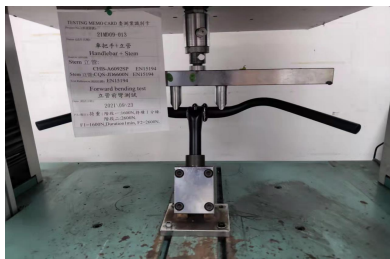
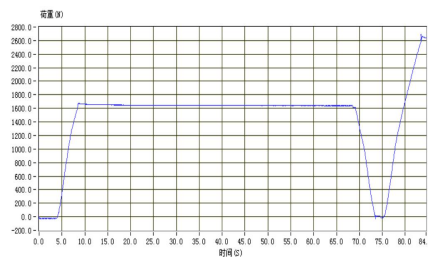
5. Appendix: Static test picture:

3. Static test: first phase:1600N. second phase: $\geq 2600N$.

4. Pass : no crack or fractures incurred in the applying-force direction .permanent deformation 10mm implement second phase' test by way of the same device, max force $\geq 2600N$

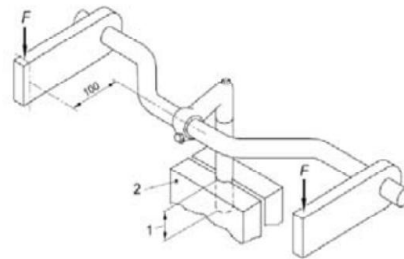
H/B + Barend + stem Torsional security test

Clamp the handlebar stem security in a fixture to the minimum insertion depth and with its axis vertical. Apply a torque of 70 Nm(accurate to within $0/\pm 5\%$) about the center -line of the stem-clamp. Divide the torque equally by vertically, downward forces applied to both sides of the handlebar and maintain the force for 1 min.

- 1 Minimum insertion depth
- 2 Clamping fixture

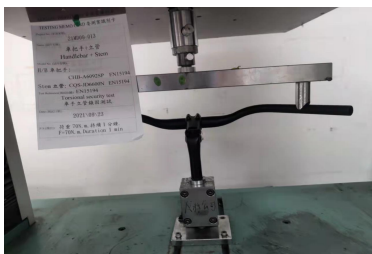
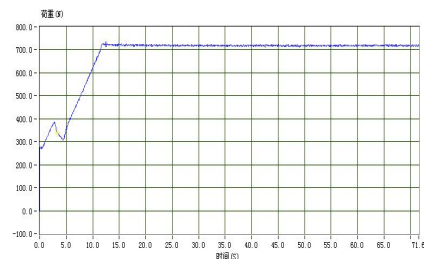
5. Appendix: Static test picture:

3. Static test: apply 70Nm in the center of stem's clamp, average the force perpendicularly, apply downwards on the 2 sides of handlebar, lasting 1 min. (Torque=force*the arm of force)

4. Pass : no displacement between stem and handle bar during testing.

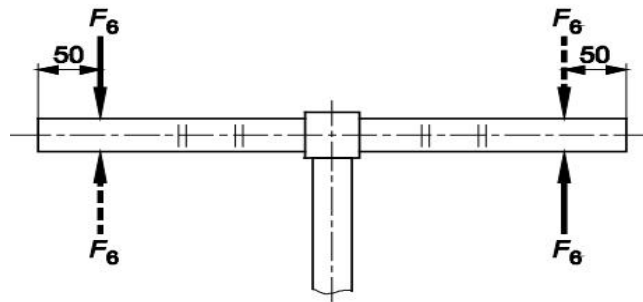
1. Endurance test out of phase:

First, Mount stem to handlebar emending degree to 90° between the grip and stem quill unless the handlebar is connected with the stem forever, Handlebar and stem are fixed tightly to the mini-insertion apply $F \pm 220\text{N}$ force to the position at the distance of 50mm, at the end of handlebar, lasting 100,000 cycle times, take advantage of the out-of-phase test on the each of handlebar at the utmost frequency of 10Hz, referring to the drawing below.

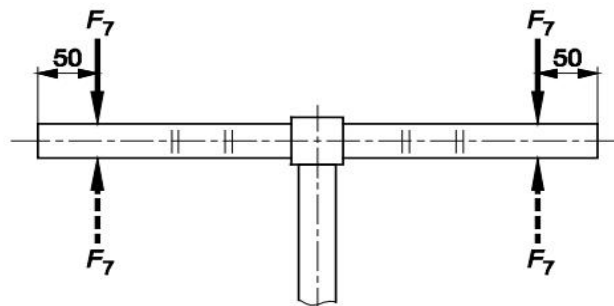
2. Endurance test in phase:

After completing in phase test for handlebar, disassembling the both sides of handlebar, then implement endurance test in phase with the same assembling way fixing pedestal. The applied cycling force is $F \pm 280\text{N}$, lasting 100,000 cycle times take advantage of in-phase test on the each of Handlebar at the utmost frequency of 10Hz, drawing as follows.

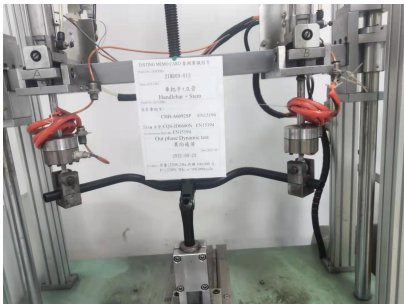
(Out phase)

3. Dynamic test: out phase, 3HZ, $F=\pm 220N$, NO1=100,100 cycle, NO2=100,101 cycle;
in phase ,3HZ, $F=\pm 280N$, NO1=100,100 cycle, NO2=100,101cycle.

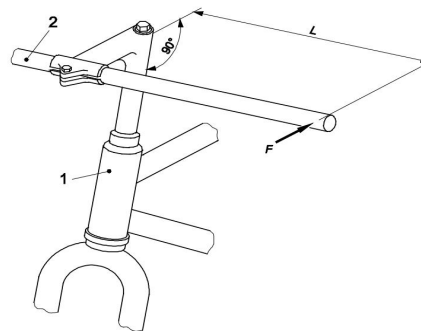
H/B+ stem + fork stem torsional security test

Assemble the fork-stem correctly in the frame and attach the handlebar-stem to the fork-stem with the locking system tightened in accordance with the manufacturer's instructions, and apply a torque of 40 Nm(accurate to within $0/\pm 5\%$) once in each direction of possible rotation in a plane perpendicular to the axis of the fork/handlebar-stem. Maintain each torque for 1min.

- 1 all frame and fork
- 2 steel rod full

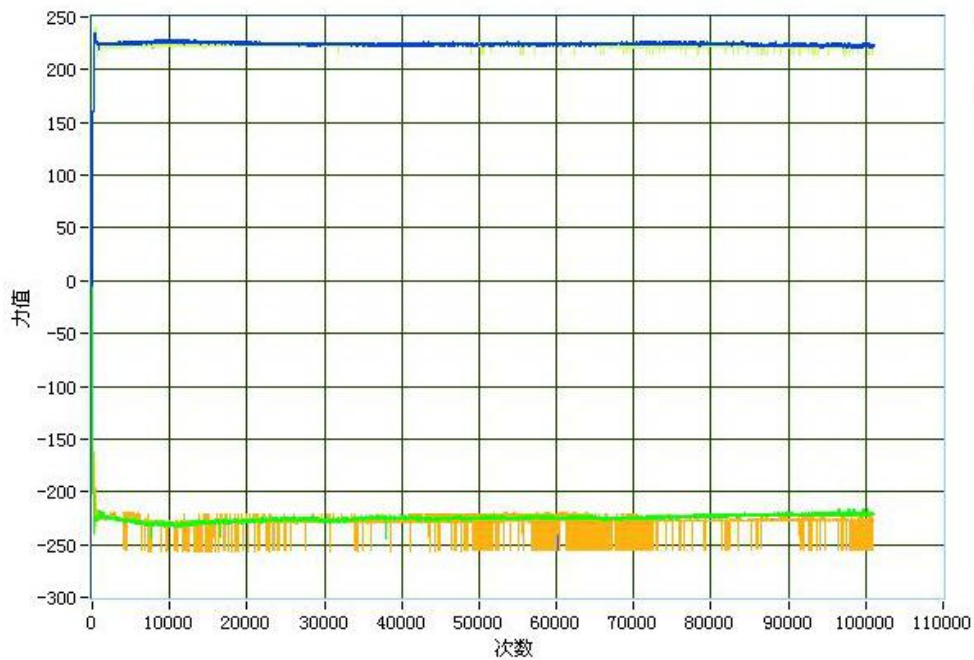
Out phase test

- 1. 试验批号 Project NO: 21MD09-013
- 2. 试验日期 Test date: 2021-09-22
- 3. 产品名称 Product : Handlebar+Stem
- 4. 试验时间 Test time: 08:42:13
- 5. 产品代号 Model No : CHB-A6092SP+CQS-JD6600N
- 6. 测试依据 Test Reference : EN15194: 2017
- 7. 试验频率 Frequency : 3.HZ
- 8. 试验次数 Setting cycle : 100,100
- 9 力量 Force : ±220 N
- 10 机器型号 Test equipment: CX-8129
- 11. 试验者 Tester 杨涛
- 12. 备注 Remark:

NO1 : 100,100 cycle no visible cracks.

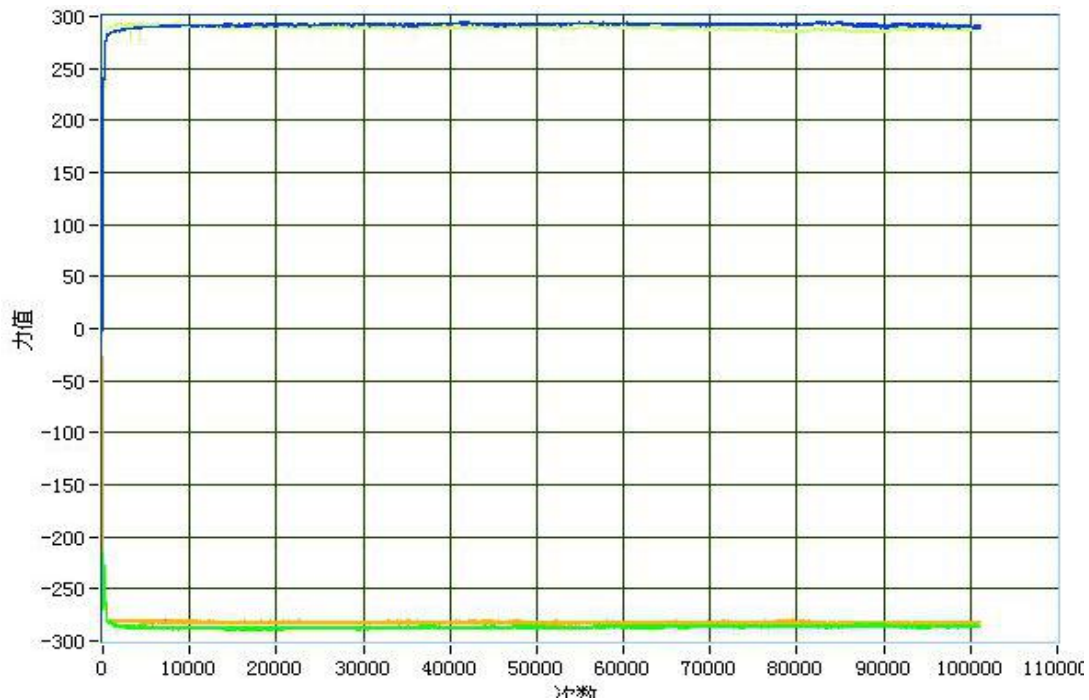
In phase test

- 1. 试验批号 Project NO: 21MD09-013
- 2. 试验日期 Test date: 2021-09-22
- 3. 产品名称 Product : Handlebar+Stem
- 4. 试验时间 Test time: 20:10:17
- 5. 产品代号 Model No :CHB-A6092SP+CQS-JD6600N
- 6. 测试依据 Test Reference EN15194: 2017
- 7. 试验频率 Frequency 3HZ
- 8. 试验次数 Setting cycle : 100,101
- 9 力量 Force : ±280 N
- 10 机器型号 Test equipment: CX-8129
- 11. 试验者 Tester 杨涛
- 12. 备注 Remark:

NO1 : 100,100 cycle no visible cracks.
