Test Report

Project NO. : 21MD10-012

Product : Handlebar+Stem

Model No. : CHB-A62041 W:660 mm
CQS-JD6258N E:105mm L:180mm

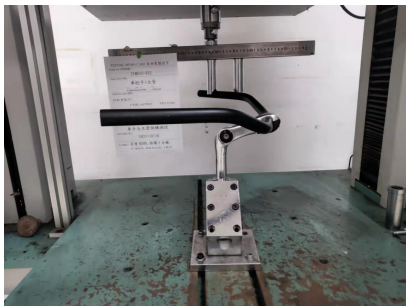
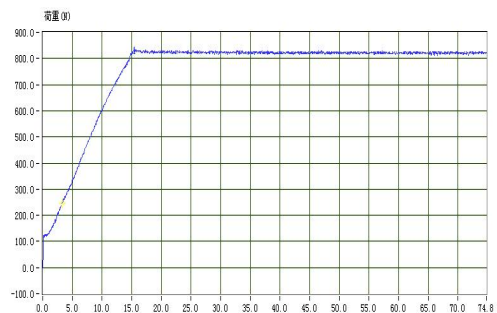
4. Appendix: Static test picture

3. Static test: acting-force:800N. Acting force place:50mm away from handle bar end lasting time:1 min

4. Pass : permanent deformation < 15mm, test based on said no crack or fracture incurred fur stem

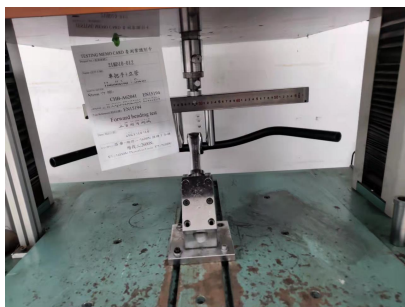
4. Appendix: Static test picture:

1. Product: Stem
2. Model No. CQS-JD6258N E:105mm L:180mm
3. Static test: first phase:1600N. second phase: $\geq 2600N$.
4. Pass : no crack or fractures incurred in the applying-force direction .permanent deformation 10mm implement second phase' test by way of the same device, max force $\geq 2600N$

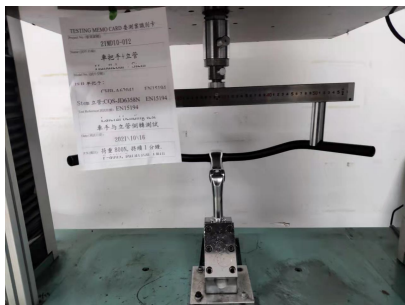
4. Appendix: Static test picture:

3. Static test: apply 70Nm in the center of stem's clamp, average the force perpendicularly, apply downwards on the 2 sides of handlebar, lasting 1 min. (Torque=force*the arm of force)

4. Pass : no displacement between stem and handle bar during testing.

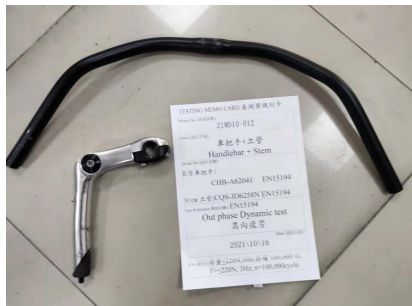
1.Test samples:

3. Dynamic test: out phase, 3HZ, $F=\pm 220N$, NO1=100,100 cycle, NO2=100,101 cycle;
in phase ,3HZ, $F=\pm 280N$, NO1=100,100 cycle, NO2=100,101cycle.

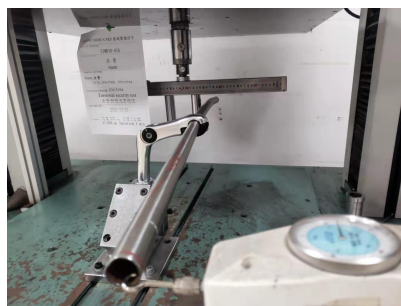
4. Appendix: Static test picture:

3. Static test: acting-torque: 50Nm. acting plane: plane perpendicular to the stem's shaft forks, lasting time: 1 min (Torque=force*the arm of force).

4. **Pass: no displace between stem and fork-stem during testing.**

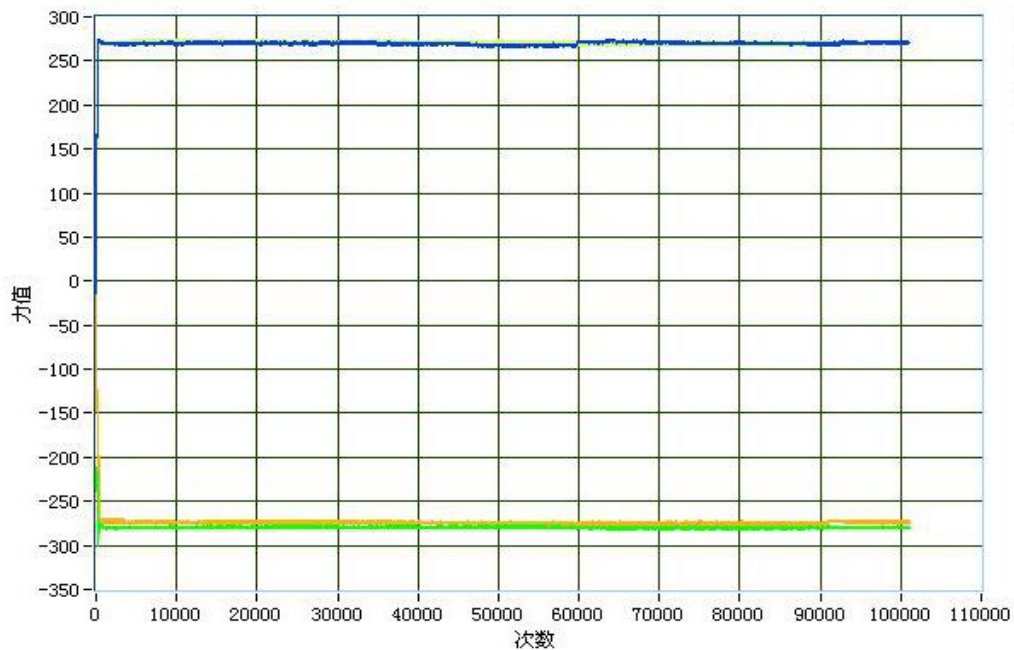
In phase test

8. 试验次数 Setting cycle : 100,101

9 力量 Force : ±280 N

NO1 : 100,100 cycle no visible cracks.
