Test Report

Project NO. : 21MD09-007

Product : Handlebar+Stem

Test Reference : EN15194:2017 (E)

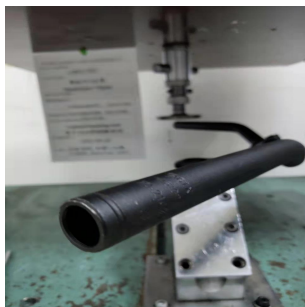
4. Appendix: Static test picture

3. Static test: acting-force:800N. Acting force place:50mm away from handle bar end lasting time:1 min

4. Pass : permanent deformation < 15mm, test based on said no crack or fracture incurred fur stem

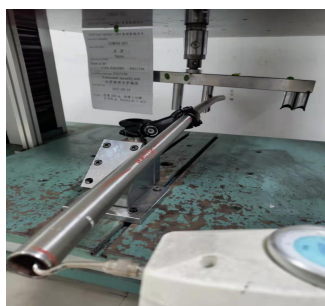
4. Appendix: Static test picture:

3. Static test: acting-torque: 50Nm. acting plane: plane perpendicular to the stem's shaft forks, lasting time: 1 min (Torque=force*the arm of force).

4. Pass: no displace between stem and fork-stem during testing.
